# Worker Pinned Beneath Lift Table

Incident Date: January 18 or 19, 2009 / Location: Slave Lake, AB / Industry: Wood Products

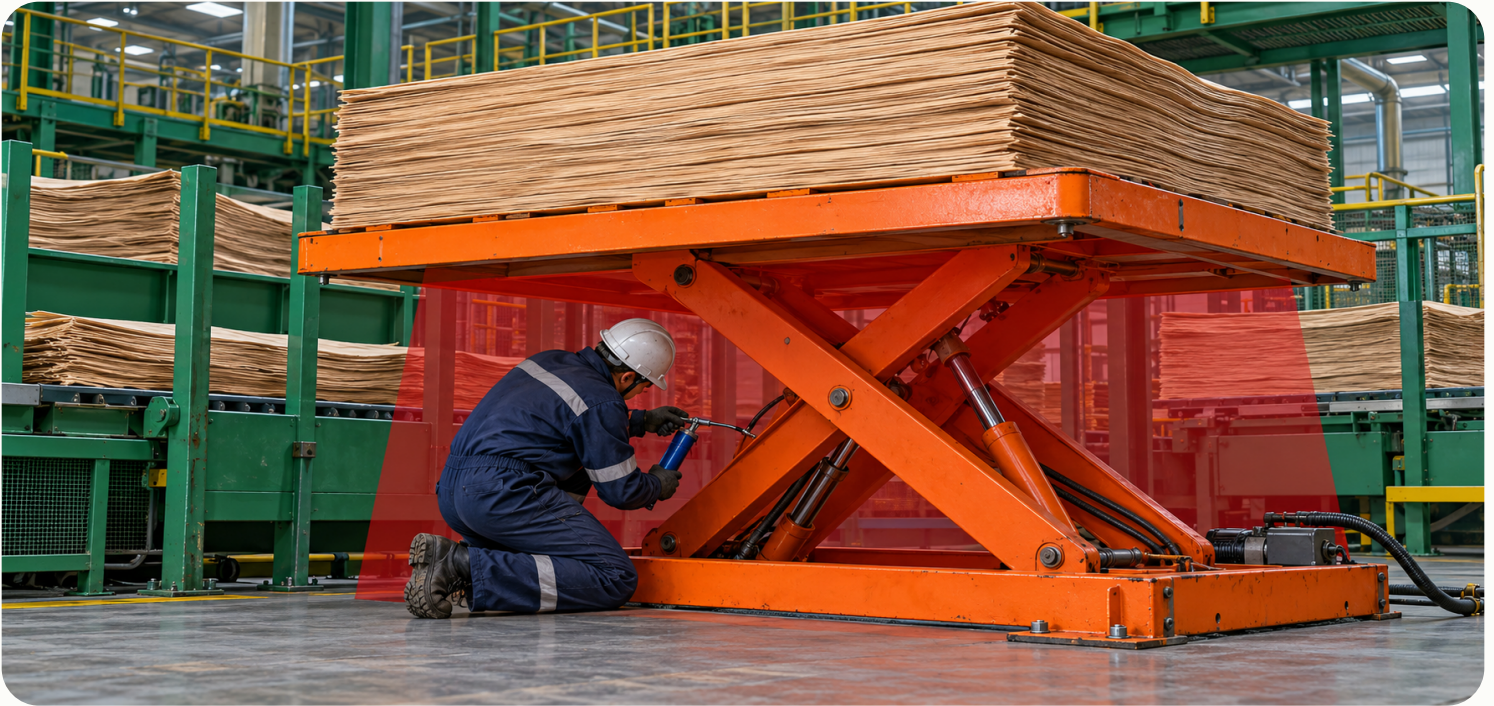
**AI Teaching Illustration.** Shows gravity and pinch-point exposure below a loaded table. Equipment and posture are schematic; no injury is depicted.

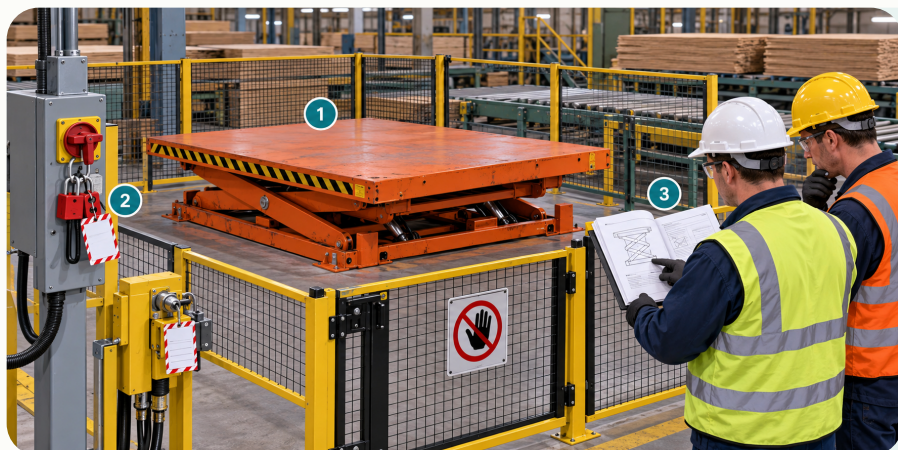
**AI Teaching Illustration.** Unloaded, lowered planning hold point; no under-table access authorized. **LSR links:** Energy Isolation; Line of Fire.

Unload and lower where possible; keep clear of pinch zones.

Apply personal locks and verify all hazardous energy controls.

Use specified support devices and a task-specific procedure before any access beneath a raised table.
