# Worker Drowned After Excavator Slid into Water

Incident Date: June 6, 2021 / Location: Aurora Mine, AB / Industry: Oil Sands

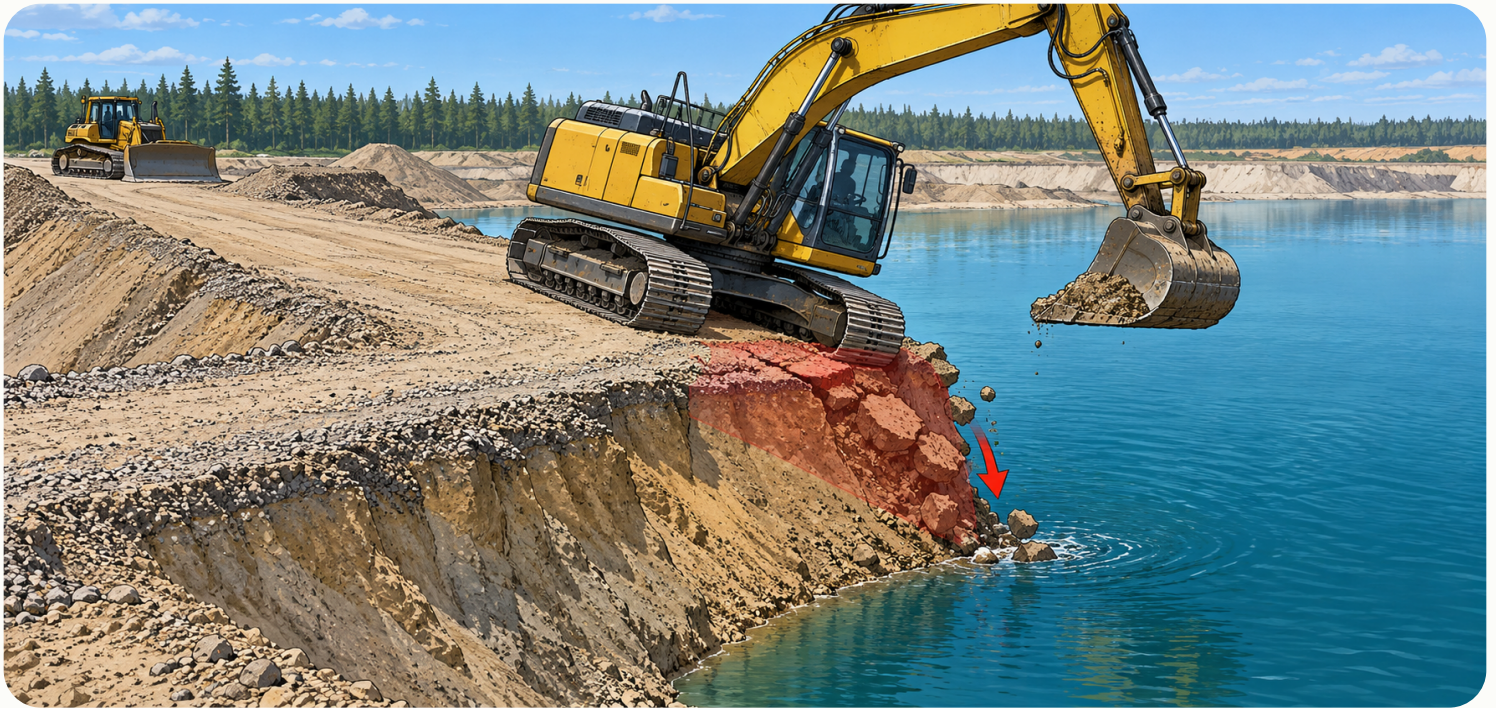
**AI Teaching Illustration.** Highlights bank failure and submersion exposure. Machine position, soil section and failure sequence are schematic; the incident was unwitnessed.

A dewatering crew was building a level pump pad and berms beside a water-filled gravel pit. The specific pump work plan had not yet been developed. A bucket push-test made the ramp appear stable, although part of its soil was soft, sandy or loose.

A team leader continued placing material with an excavator while another operator moved aggregate with a dozer. The ramp's south bank sloughed. The excavator slid down the embankment and toppled, submerging its cab in sand and water. The other operator discovered the machine and called for help. The team leader drowned.

**The ramp's over-steepened slope was unsafe for excavator access.** A firm-looking surface and bucket push-test did not establish safe ground support. The bank failed under the work. The machine had no contributing defects, and its escape hatch and glass breaker did not prevent the fatal outcome.

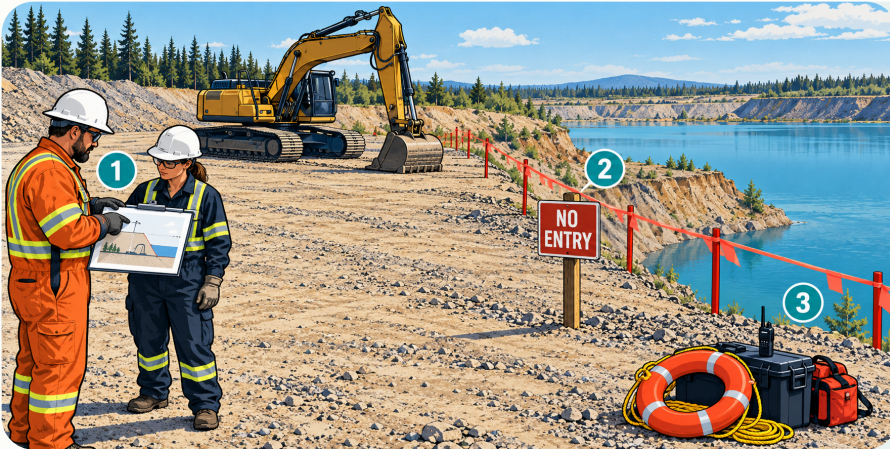
**AI Teaching Illustration.** A planning hold point; shown distances and machine position are not an operating design. **LSR links:** Ground Disturbance; Line of Fire.

### 1 Assess the Ground

Confirm soil, slope and load capacity with competent input.

### 2 Define Safe Access

Set approved routes, setbacks and operating positions.

### 3 Prepare for Emergency

Plan communication, escape and water rescue before work starts.
