# Worker Crushed by Falling Ice

Incident Date: December 31, 2008 / Location: Mildred Lake, AB / Industry: Oil Sands

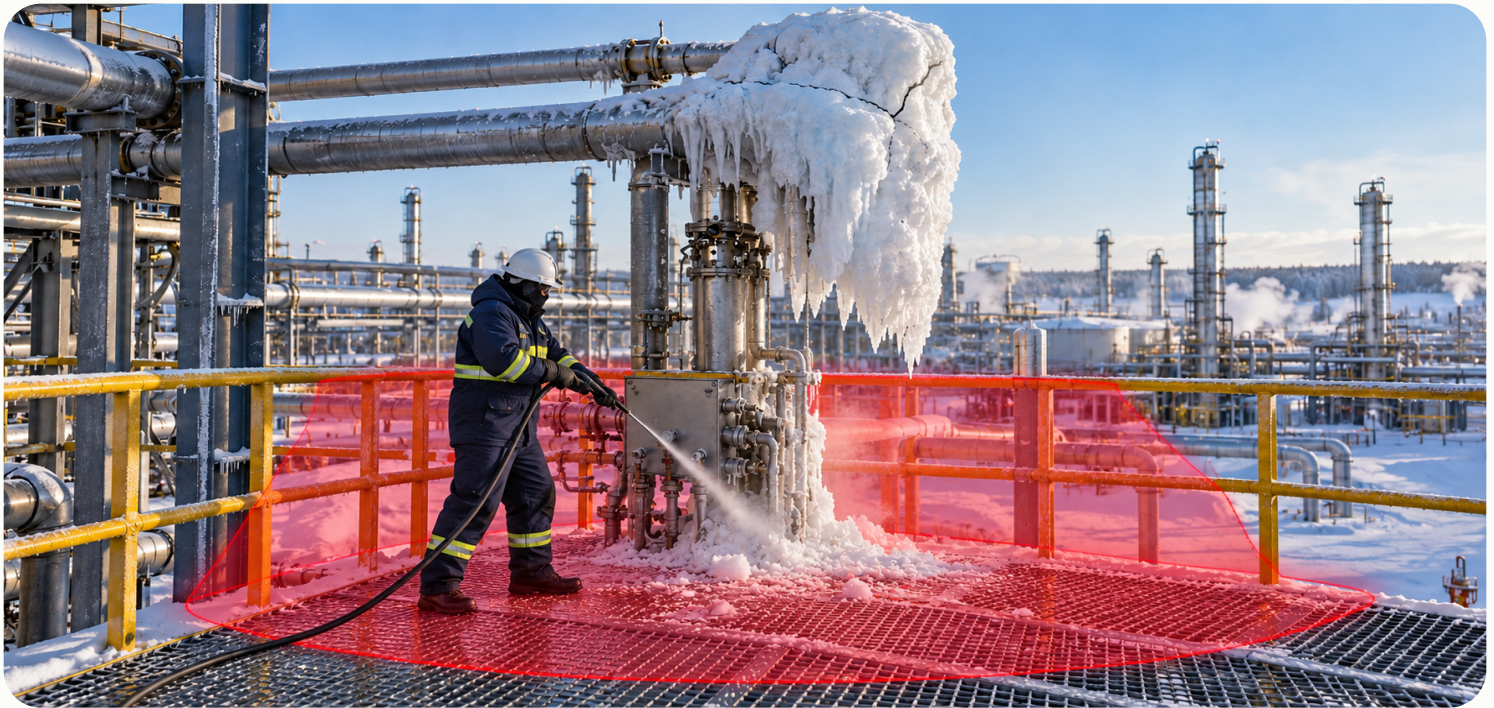
**AI Teaching Illustration.** Shows an unstable ice mass after its lower support melts. Shape, position and red exposure zone are schematic.

A process operator was clearing ice so a maintenance crew could repair steam-tracer leaks. A large ice mass had grown from the platform, around a railing and over a manifold box. Steam lances had been left running overnight as ice was melted from the bottom.

The remaining mass became unstable, fell and rotated onto the platform, striking the operator or crushing the worker against railings and pipes. It weighed an estimated 545–727 kilograms. The operator moved toward an access ladder and collapsed. Arriving maintenance workers called for help. Emergency responders took the worker to hospital, where the worker died.

**Melting the base removed support from a heavy ice mass.** OHS found no task hazard assessment, effective ice-removal controls or formal training. A written procedure was still being developed. The report could not establish whether the operator had completed a personal field-level risk assessment.

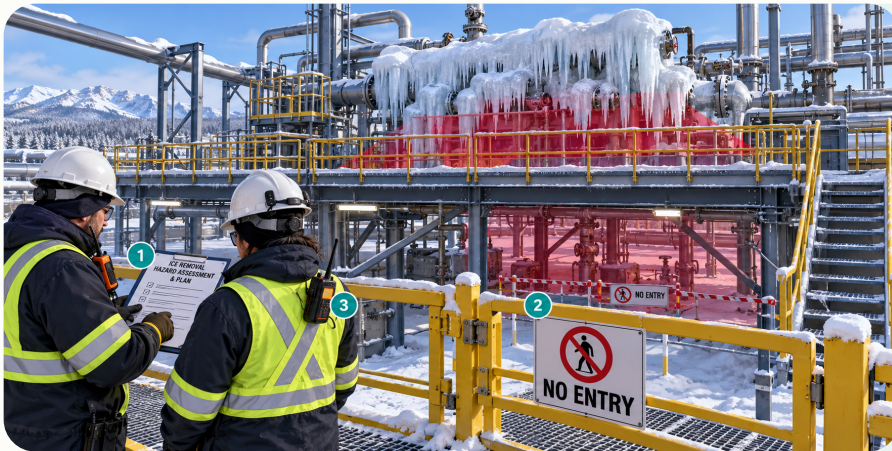
**AI Teaching Illustration.** Access closed pending an approved method; shown distances are not a design. **LSR links:** Line of Fire; Energy Isolation.

Assess the entire ice mass before changing what supports it.

Use a written assessment and a competent removal plan.

Keep people out of the drop and rotation zones, including below.

Control leaks and energy. Reassess as ice melts; confirm communication and rescue arrangements.
