# Worker Burned by Hot-Water Release

Incident Date: August 18, 2014 / Location: Brooks, AB / Industry: Food Processing

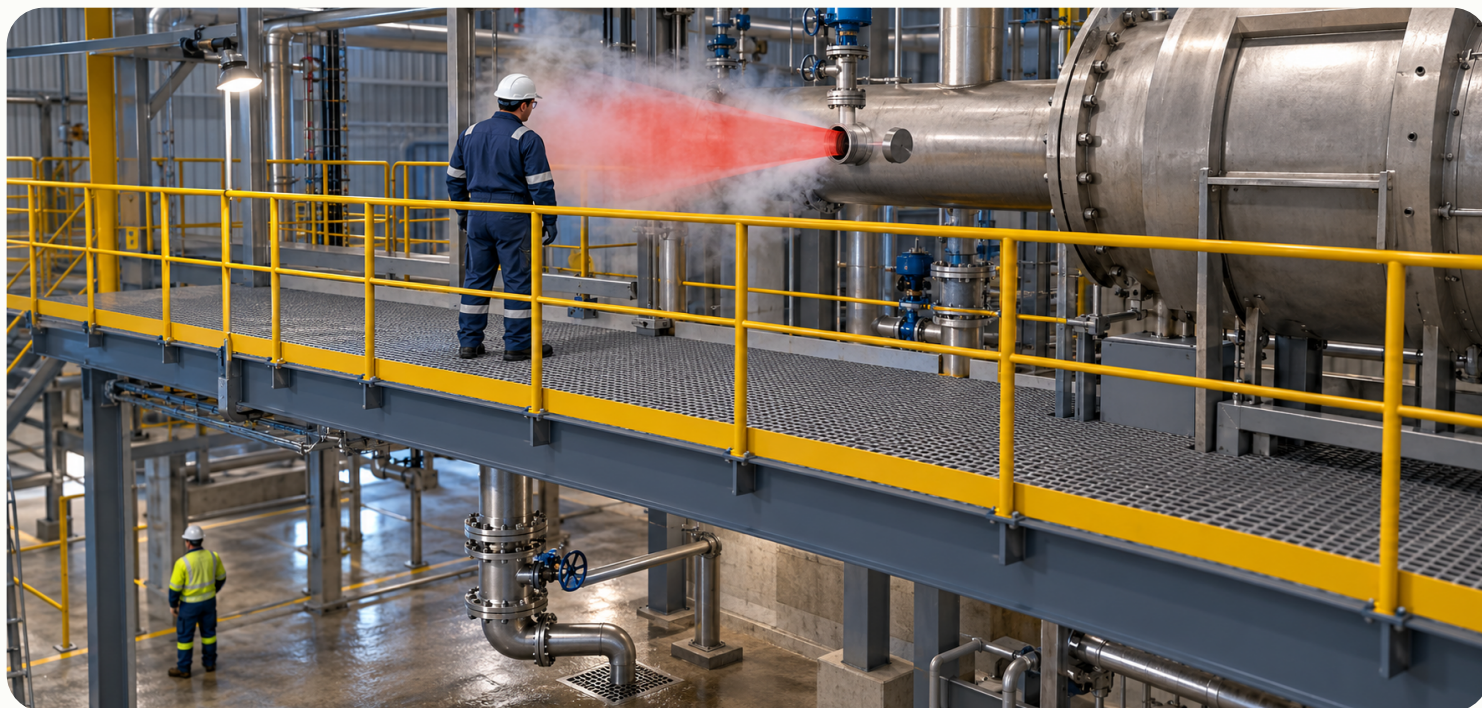
**AI Teaching Illustration.** Shows exposure to a hot-fluid release near a mezzanine. Pipe layout and release zone are schematic; how the cap came off is uncertain.

A rendering feeder line had blocked repeatedly. Planned dismantling had not taken place, so a superintendent and supervisor tried flushing it. A new water connection was installed. They added water, steam and air to loosen and move the blockage, then began draining the line.

The supervisor returned to the mezzanine near the cooker while the superintendent watched from below. A cap on the feeder line was removed or dislodged, releasing steam-heated water toward the platform. The supervisor suffered severe burns. Co-workers helped the worker to an emergency shower and medical care. The worker died in hospital 41 days later.

**Hot water escaped from an opening facing the worker's position.** Draining had begun, but hazardous heat and fluid remained. The report does not establish whether the cap was removed or dislodged. A blockage can complicate drainage and pressure verification; changing the troubleshooting method requires a fresh assessment.

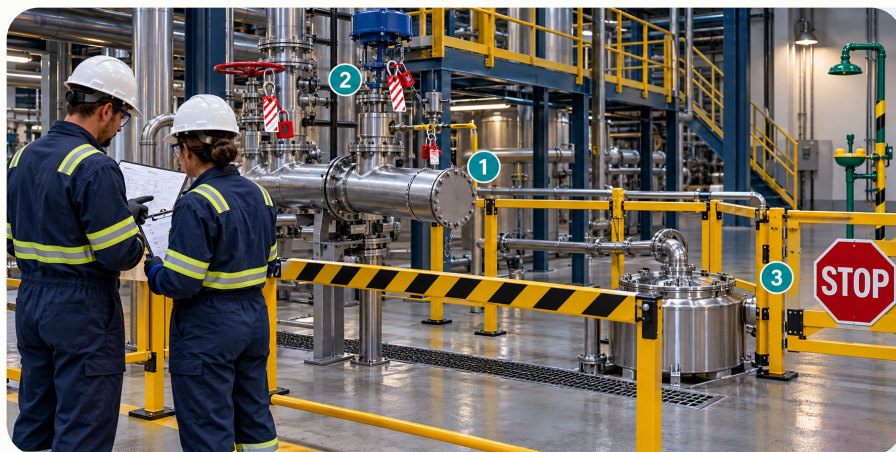
**AI Teaching Illustration.** Work paused for verification; piping and isolation are conceptual. **LSR links:** Energy Isolation; Line of Fire.

Verify pressure, temperature and drainage before opening a process line.

Use an approved plan for blockages and piping modifications.

Control all sources; verify pressure and safe temperature.

Use approved drains and containment. Keep people clear and emergency washing facilities accessible.
