# Worker Crushed by Cinderblock Wall

Incident Date: November 20, 2014 / Location: Calgary, AB / Industry: Construction

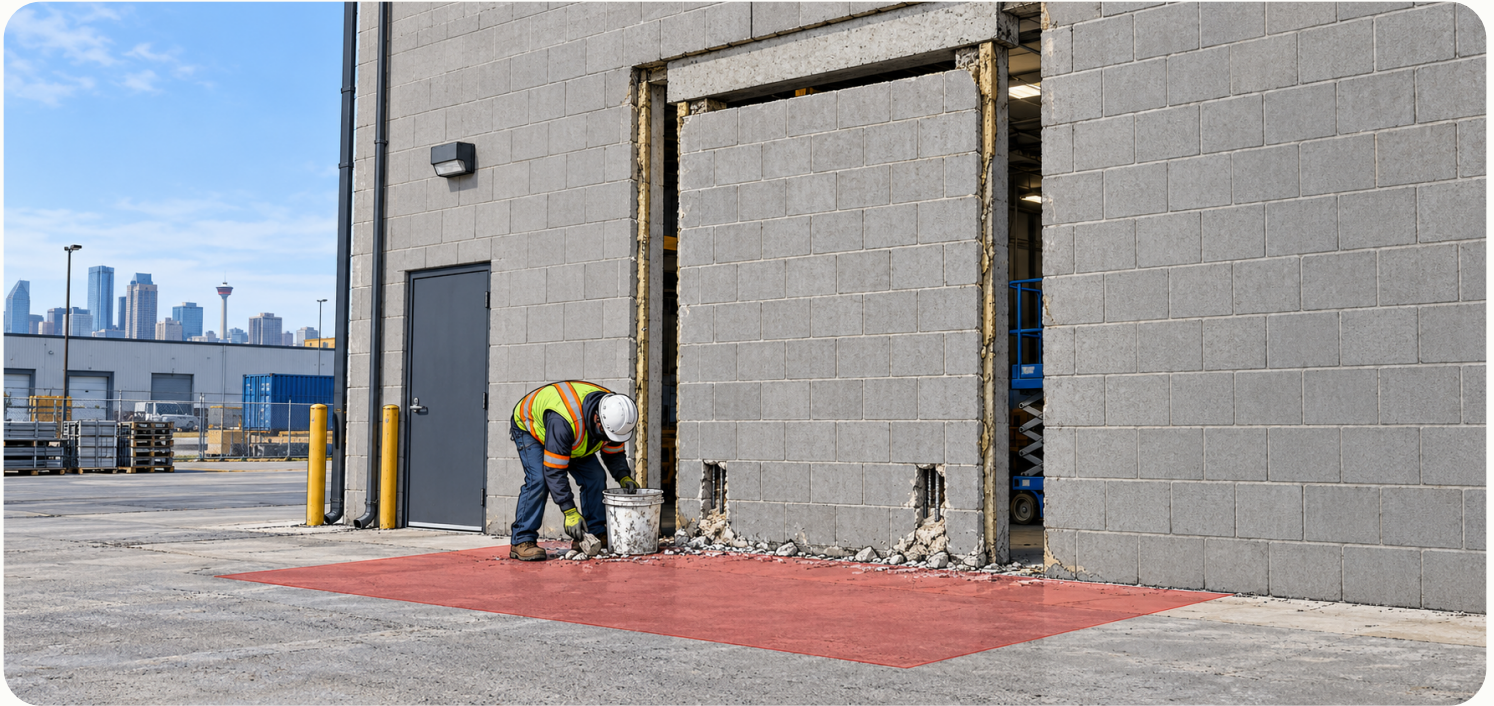
**AI Teaching Illustration.** Shows the detached wall and potential collapse area before injury. Layout, tools and worker position are conceptual.

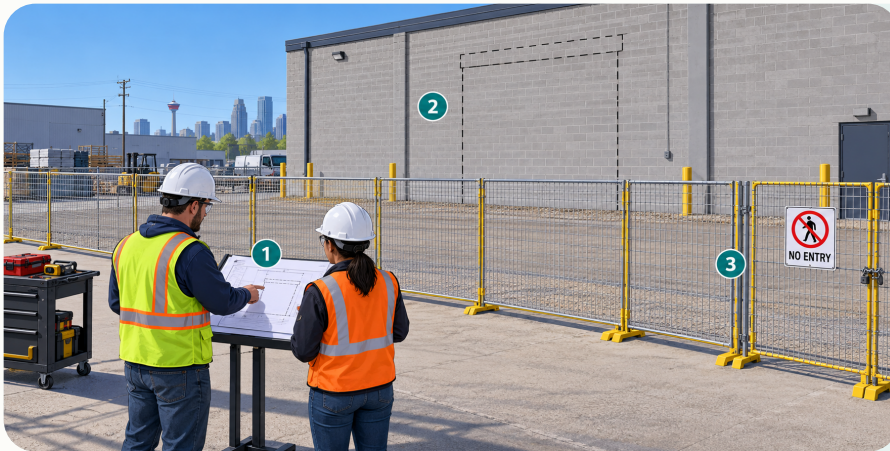
**AI Teaching Illustration.** Pework hold point before cutting; support design is site-specific. **LSR link:** Line of Fire.
