# Worker Electrocuted by Live Utility Bus

Incident Date: September 8, 2022 / Location: Near Fort McMurray, AB / Industry: Electrical Wiring

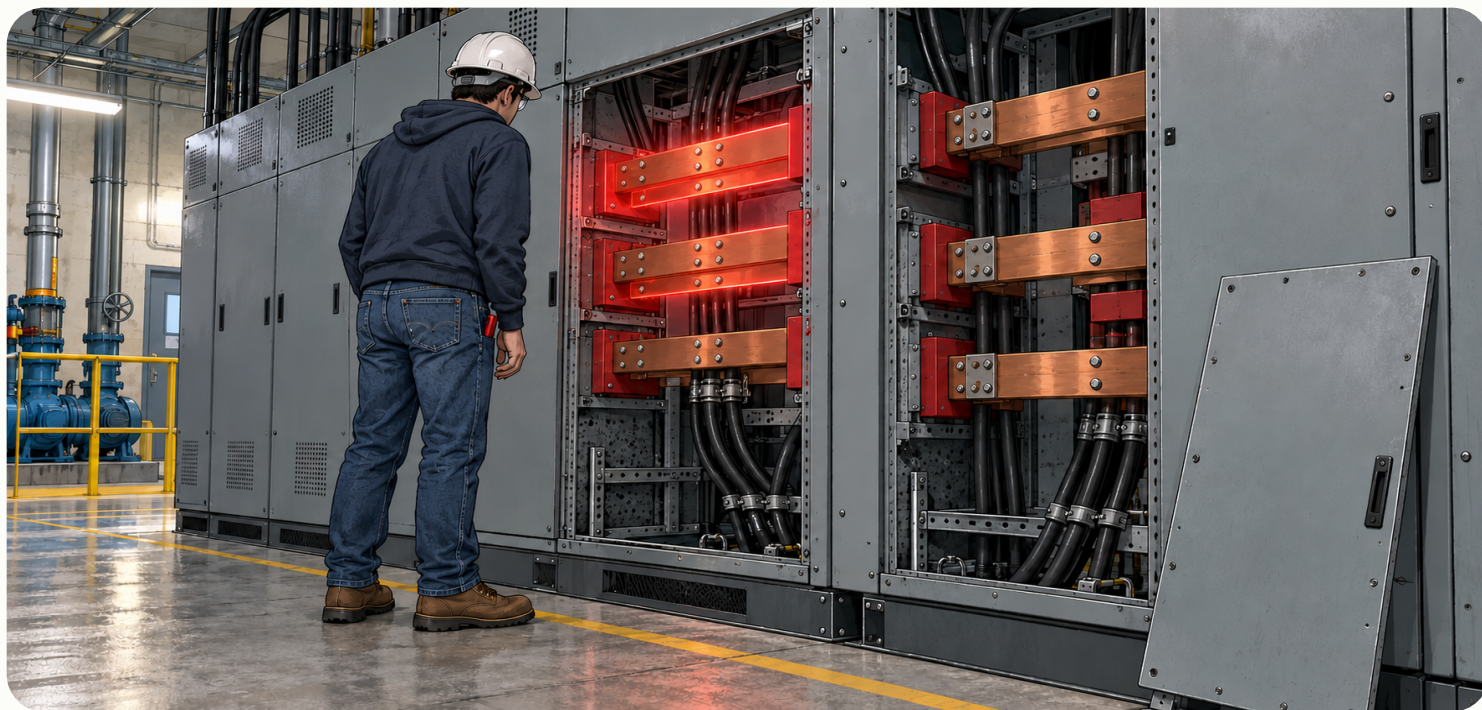
**AI Teaching Illustration.** Conceptual exposed switchgear before contact; red highlighting identifies the electrical hazard. The incident was unwitnessed.

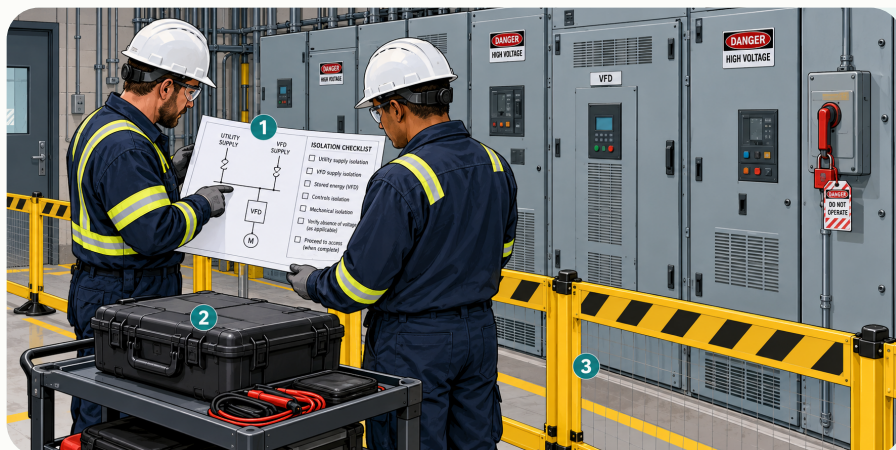
Identify every supply and verify the work boundary before access.

**AI Teaching Illustration.** Planning hold point, before access or voltage testing. Diagram is schematic. **LSR link:** Energy Isolation.

### 1 Identify and Isolate

Confirm all sources and the exact work scope; isolate and lock out.

### 2 Verify Before Touch

Have qualified workers test with suitable equipment and task-specific PPE.

### 3 Protect the Boundary

Secure covers and barriers around live parts; stop if the work scope changes.
