# Worker Run Over by Truck

Incident Date: August 19, 2024 / Location: Spruce Grove, AB / Industry: Pipeline Construction

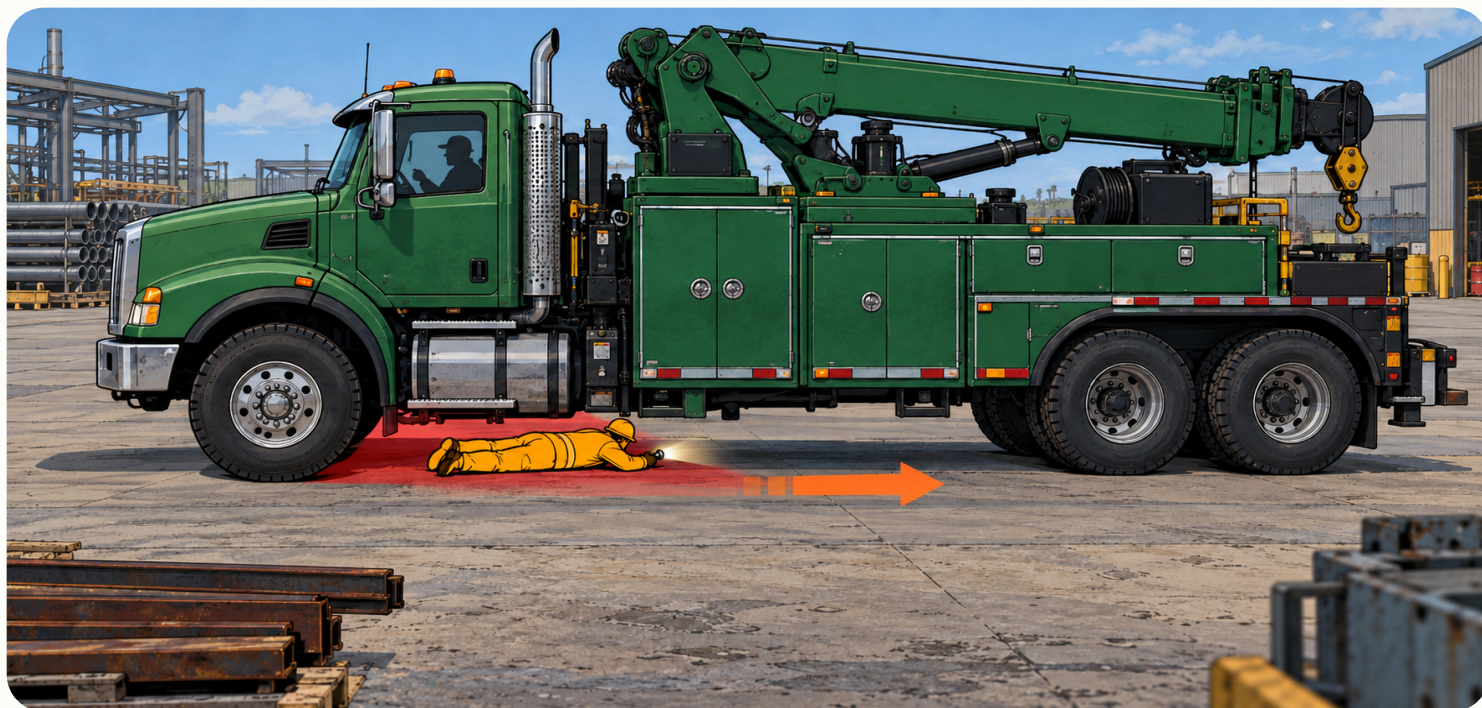
**AI Teaching Illustration.** The shaded area shows the reversing path behind the front passenger-side tire. Vehicle, pose and spacing are illustrative, not an exact reconstruction.

Two apprentice mechanics at Murphy Group Canada's Spruce Grove yard finished testing repairs on a picker-boom truck. They spoke, and the driver was advised they could prepare to move. The first-year mechanic then knelt and lay behind the front passenger-side tire with a flashlight.

Unaware of the mechanic's position, the driver reversed seconds later, running over and fatally injuring them. The sequence lasted about 27 seconds. Both workers had signed the morning hazard assessment, and the backup alarm worked. Why the mechanic went underneath remains unknown.

The change from maintenance to movement left a worker in the tire's path, unknown to the driver. OHS identified timing and body position in a danger area. **A signed assessment and a working alarm did not ensure everyone was clear.**

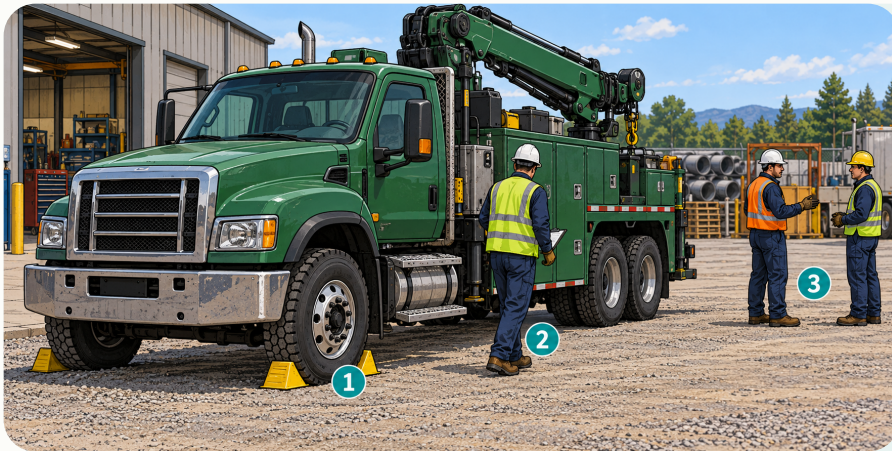
**AI Teaching Illustration.** Stationary maintenance/handover concept. Chocks alone are not full isolation; clear controls through the approved procedure. **LSR links:** Line of Fire / Energy Isolation.

### 1 Prevent Movement

Before work underneath, isolate and secure using the approved procedure.

### 2 Account for Everyone

Complete the walk-around and check all danger areas.

### 3 Confirm the Handover

Positively confirm clearance before authorizing vehicle movement.
